Technical Bulletin

(1005346 Rev. A)

June 26, 2006

1004685 (2000S-2500-TR)

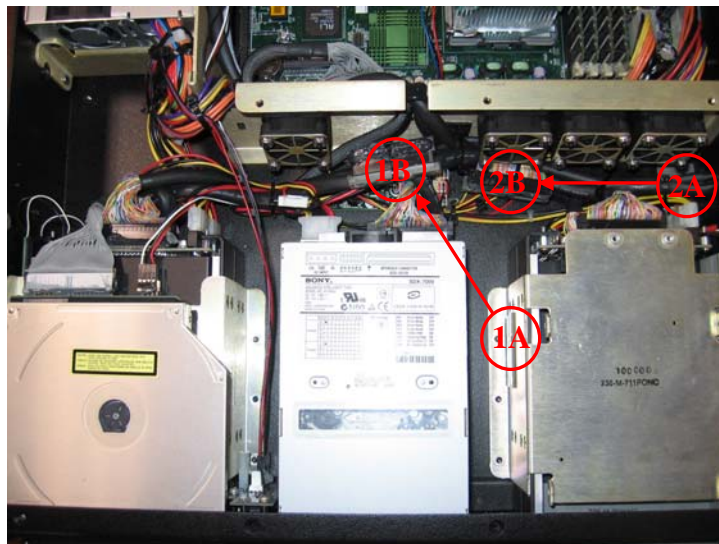
In some instances the un-terminated SCSI cable connectors may contact metal causing a short.

Figure 1 – Picture of SCSI connectors repositioned
(Server shown with cover removed)

Cable Tie the un-terminated SCSI cable connectors to SCSI cable bundle.

1. Remove server from rack.
2. Remove screws that fasten the cover of the server, and then remove the cover.
3. Referring to Figure 1 reposition the 2 un-terminated SCSI connectors as follows:
 - a. The circles labeled 1A and 2A represent the original connector positions. Use a flat head screwdriver to unseat the connectors from the locations they are taped to.
 - b. Cut cable ties as needed to allow for repositioning of the connectors.
 - c. Cable Tie the connectors to the SCSI cable bundle in the locations indicated by circles 1B and 2B.
4. Refasten cover of server using screws removed in step 2.
